9113 Sandoval

**BUILDING AND STANDARDS BOARD AGENDA ITEM #7 FOR
WEDNESDAY, MARCH 26, 2014**

**ENVIRONMENTAL SERVICES DEPARTMENT
CODE COMPLIANCE DIVISION**

SUBJECT: 9113 Sandoval, El Paso, Texas, 79907

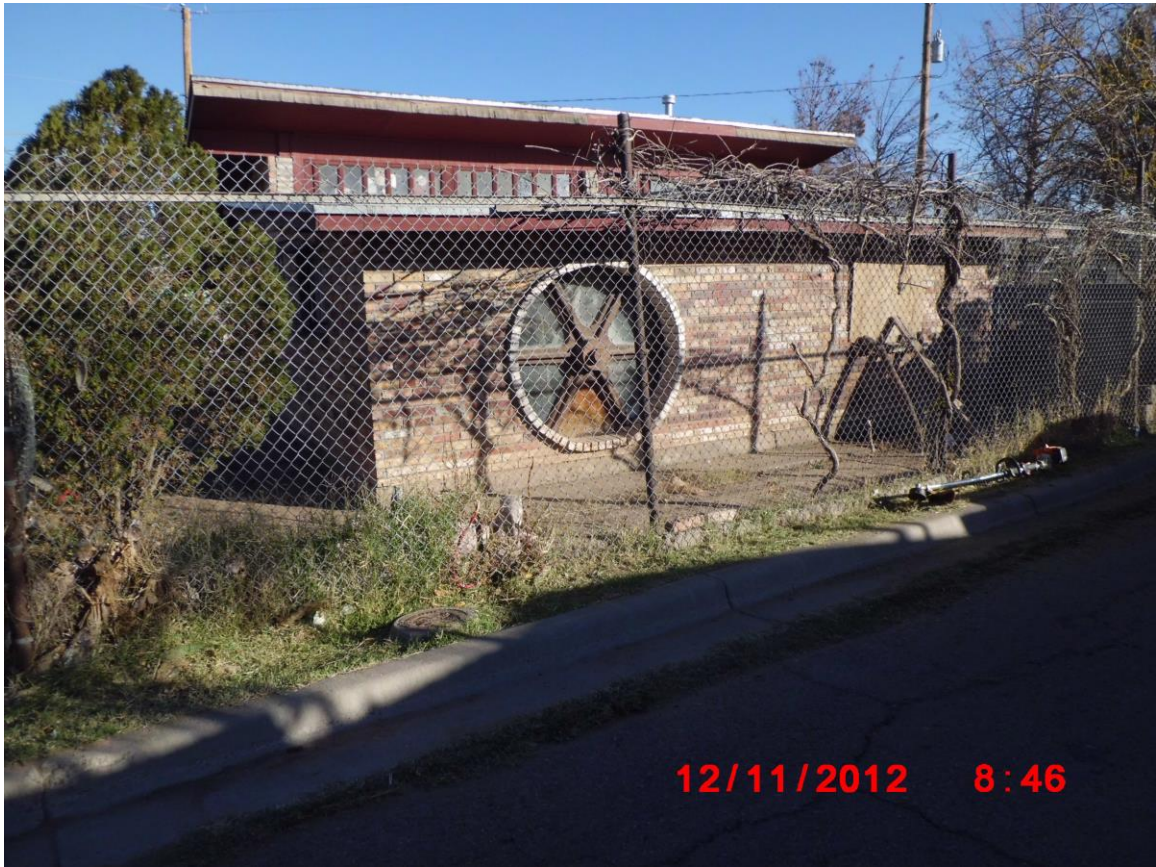
- 1) First investigated on or about October 26th, 2011 and most recently, October 9th, 2012. The structures were found occupied without any utilities, trash service or minimum required facilities. There was urine being discharged through the front window and there was a strong odor of human feces throughout the dwelling. The structures were found to be in an advanced state of disrepair, the rear wall supported by an Adobe stem wall is protruding outward and nearing collapse. There are numerous structural cracks throughout the CMU walls.
- 2) A certified condemnation letter was mailed to Roberto Loera, 305 Alton Griffin St., Ysleta Del Sur Pueblo, TX 79907
- 3) Certified notices of the public hearing scheduled for March 26, 2014, were mailed to the owners and all interested parties on MARCH 06, 2014.
- 4) As of March 12, 2014, **\$9,831.39** is owed in taxes.

CONDITION: Poor. Large structural cracks throughout brick veneer and underlying C.M.U.

REMARKS: This single family residence was constructed in 1943. The structures were found occupied with no utilities, trash service, or minimum required facilities. The structures are in an advanced state of disrepair. The rear wall supported on Adobe stem wall is leaning outward, and there are numerous structural cracks in C.M.U. walls. The department recommends that the structures be demolished within thirty (30) days as it poses a health and fire hazard, and also be cleaned of all weeds, trash and debris within thirty (30) days.

- 3) That the structure's certificate of occupancy be revoked; and
- 4) That the structures cannot be rehabilitated; and
- 5) That all the structures be **demolished** within thirty (30) days; and
